## **FIELD OBSERVATION REPORT HARBOUR POINT GARDENS**

**Project:**  
Harbour Point Gardens  
138-188 Delaware Avenue, Troy, NY

**Project No.:** CZ321AW.14  
**Date Issued:** 07/06/2023

**Owner:**  
Lexington Property Group

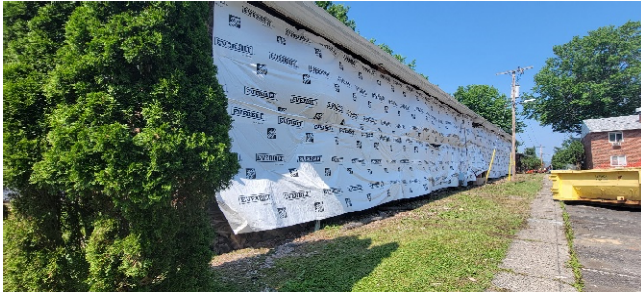
Photograph (1): Brick removal and temporary weather protection ongoing. Representative condition.

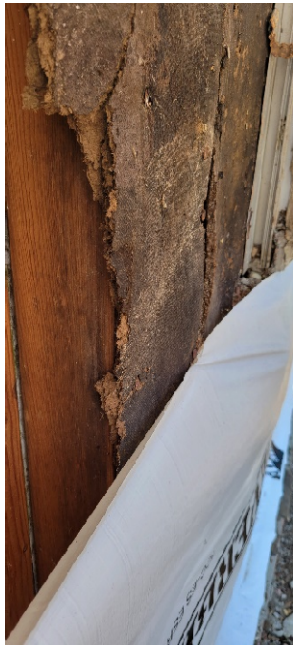
Photograph (2): Missing or damaged sheathing and framing behind temporary weather protection. Representative condition.

3. The repair work is subject to a building permit issued by the City of Troy. Prior to commencing repairs, a building permit must be obtained. This will require certified construction documents associated with repair / replacement of damaged / missing insulation, sheathing, framing, flashing, fenestration, trim, finishes, electrical systems, roof drainage systems, soffits, etc. as required by the 2020 NYS Existing Building Code.

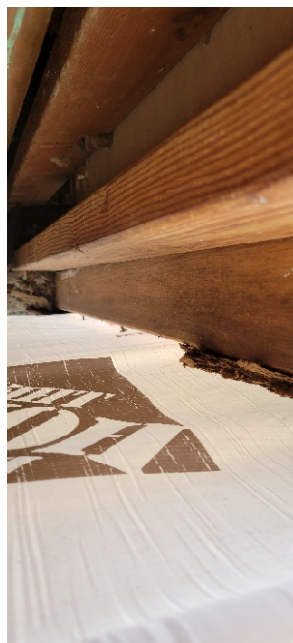
Photograph (3): Missing or damaged sheathing and framing behind temporary weather protection. Representative condition.

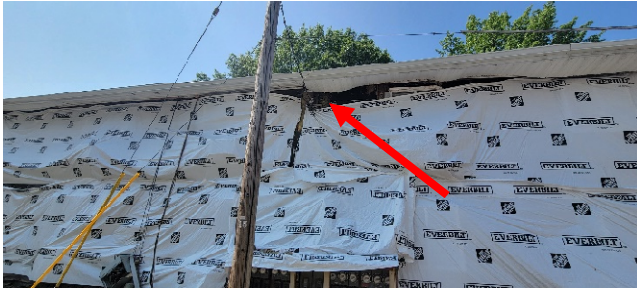
Photograph (4): Missing or damaged sheathing and framing behind temporary weather protection. Representative condition.

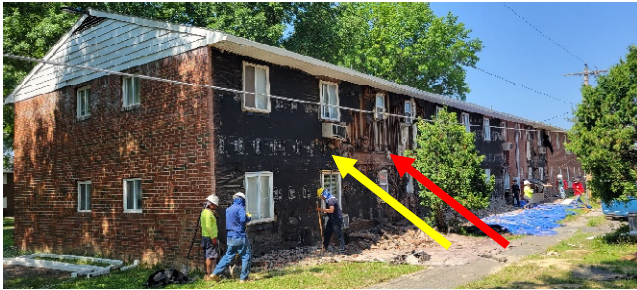
Photograph (5): Missing or damaged sheathing and framing (red arrow) and penetration through wall assembly with damaged interior finishes (yellow arrow). Representative condition.

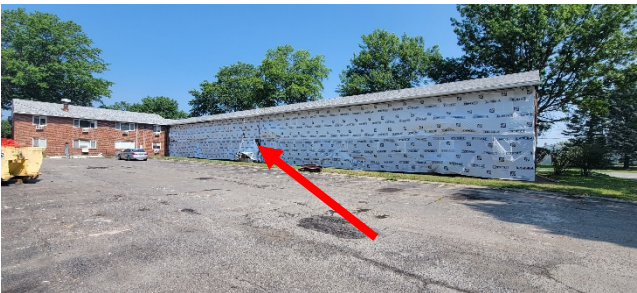
Photograph (6): Damaged electric service.

- i. Restoring power (following inspections by qualified inspectors)
    - ii. Providing temporary weather protection
    - iii. Restoring light, ventilation and egress (i.e. operable windows)

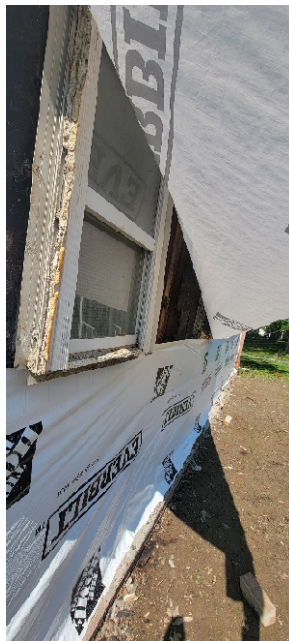
Photograph (7): Unsecured window. Representative condition.
